Report on Damage to Overmyer Murals in the Kansas Statehouse

Prepared by Nikaela J. Zimmerman, Museum Registrar

Kansas Historical Society

20 March 2018

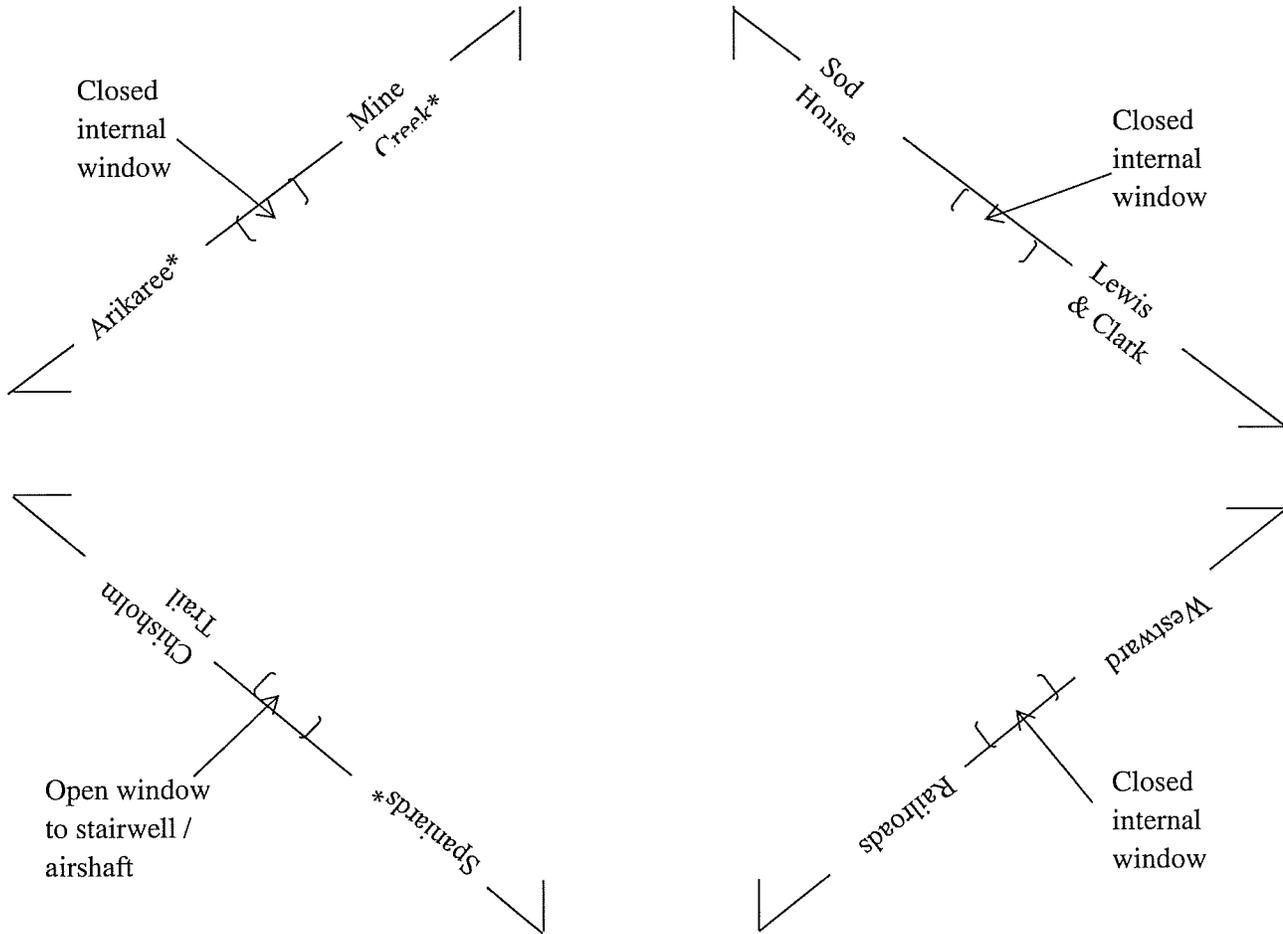
The murals that show the most damage are located in the southeast and northeast areas of the rotunda. The murals located on the western half show very little to no damage.

There is an air shaft / stairwell in the northeast corner of the rotunda. Windows that open into the shaft are left open and there is a good draft of air that comes into the rotunda from the air shaft / stairwell. The

murals with the most damage are located adjacent to the airshaft / stairwell. The following illustration shows the layout of the murals in relation to the stairwell/airshaft and doorways.
